**FLORIDA DEPARTMENT OF TRANSPORTATION  
BRIDGE MANAGEMENT SYSTEM****Inspection/CIDR Report with PDF attachment(s)  
Inspection****Structure ID: 705909****DISTRICT: D5 - Deland****INSPECTION DATE: 3/20/2018 TUUI**

BY:	Ayres Associates	STRUCTURE NAME:	Jupiter Blvd-M-T Canal
OWNER:	4 City/Municipal Hwy Agy	YEAR BUILT:	1975
MAINTAINED BY:	4 City/Municipal Hwy Agy	SECTION NO.:	70 000 207
STRUCTURE TYPE:	5 Prestressed Concrete - 02 Stringer/Girder	MP:	5.408
LOCATION:	1 mi N of Malabar Road	ROUTE:	00000
SERV. TYPE ON:	5 Highway-pedestrian	FACILITY CARRIED:	Jupiter Blvd.
SERV. TYPE UNDER:	5 Waterway	FEATURE INTERSECTED:	Melbourne Tillman Canal

TYPE OF INSPECTION: Regular NBI

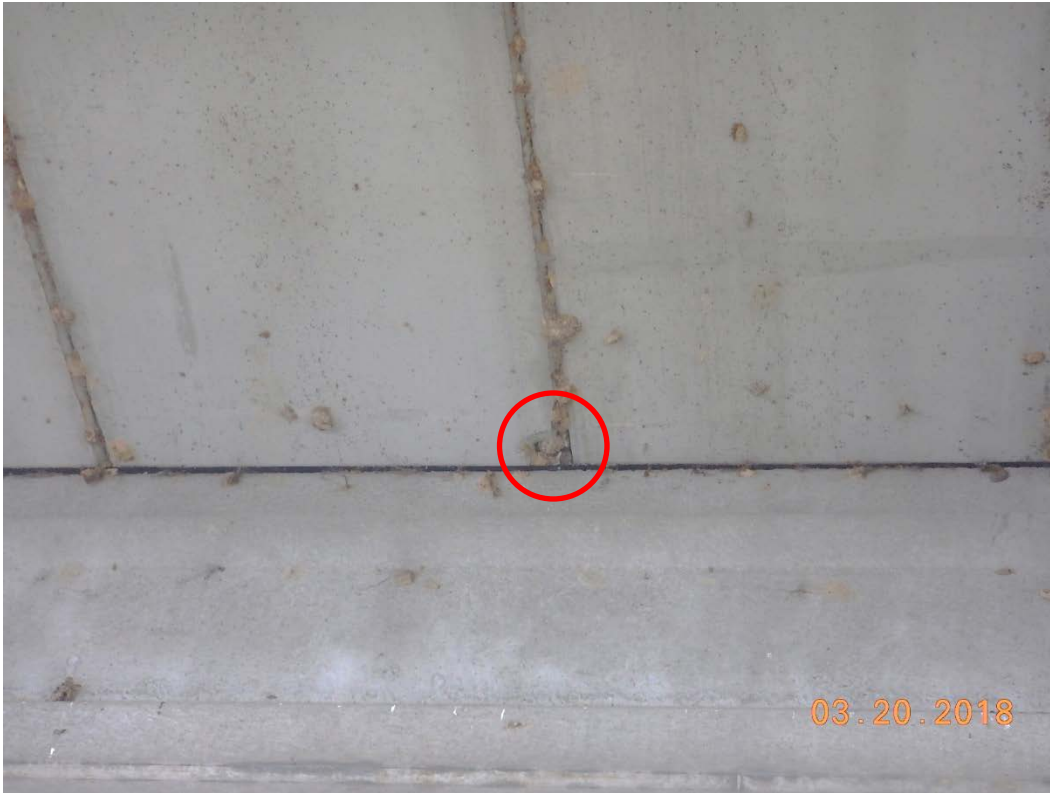
The underside of Bay 1-1 Panel 8 has a 4 in. x 3 in. x 1-1/2 in. spall with exposed steel in the southeast corner. Refer to Photo 1.

Photo 1: Element 8098: Showing spall with exposed steel Panel 8 in Bay 1-1

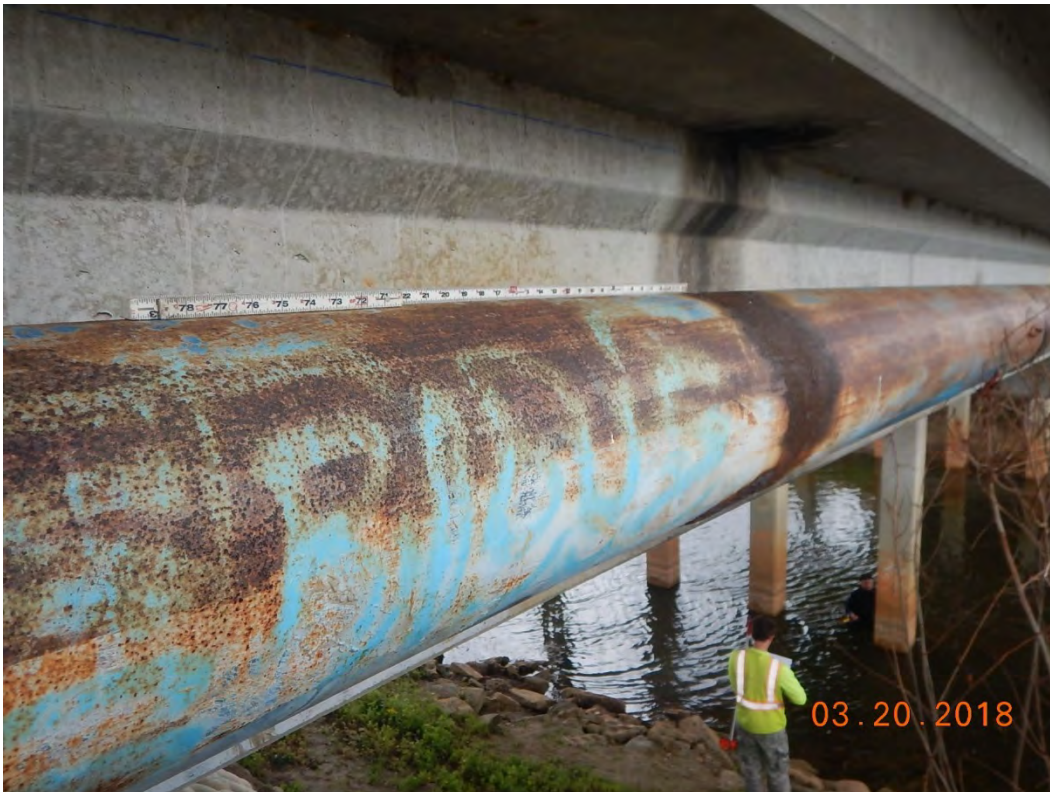
The utility pipe along the right side of the structure has areas of heavy corrosion and is leaking. Refer to Photo 2. REPAIR

Photo 2: Element 8098: Showing heavy corrosion and leaking utility pipe on right side of the structure.

Replace / repair corroded and leaking utility pipe along the right side of the structure.

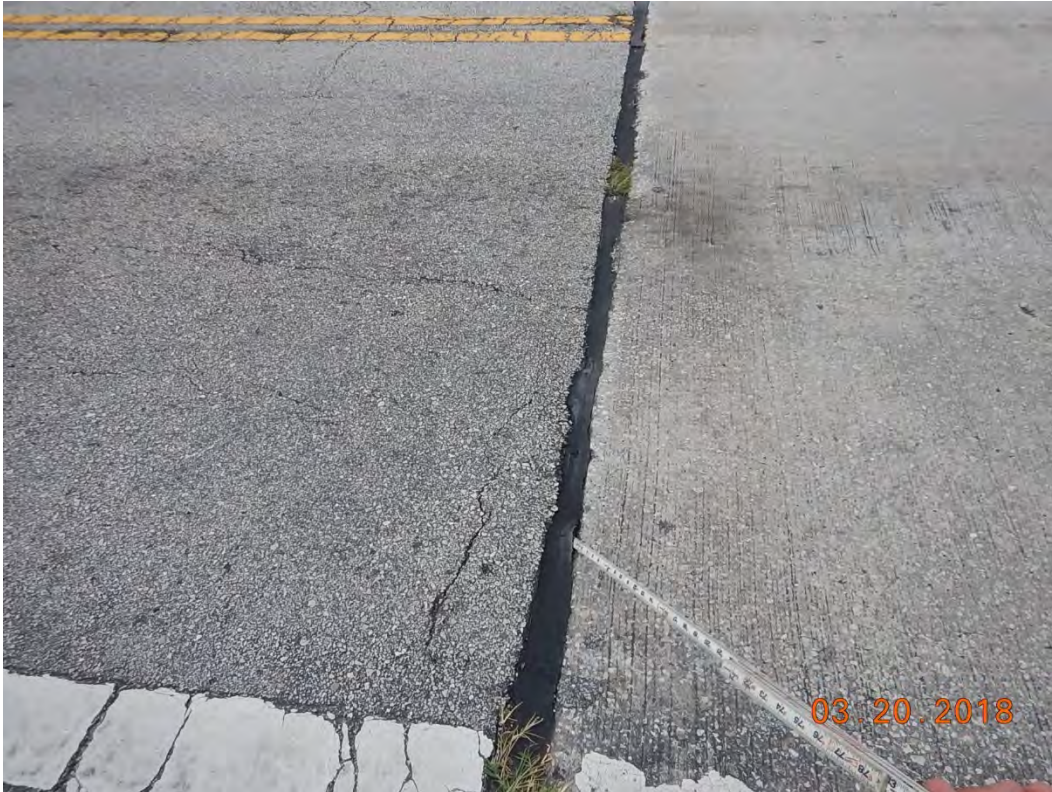
CS3 = All expansion joints have adhesion failures up to 10 ft. long each. Refer to Photo

Photo 3: Element 301: Showing typical adhesion failure of expansion joint sealant.

Repair all areas where the expansion joint sealant has adhesion loss.

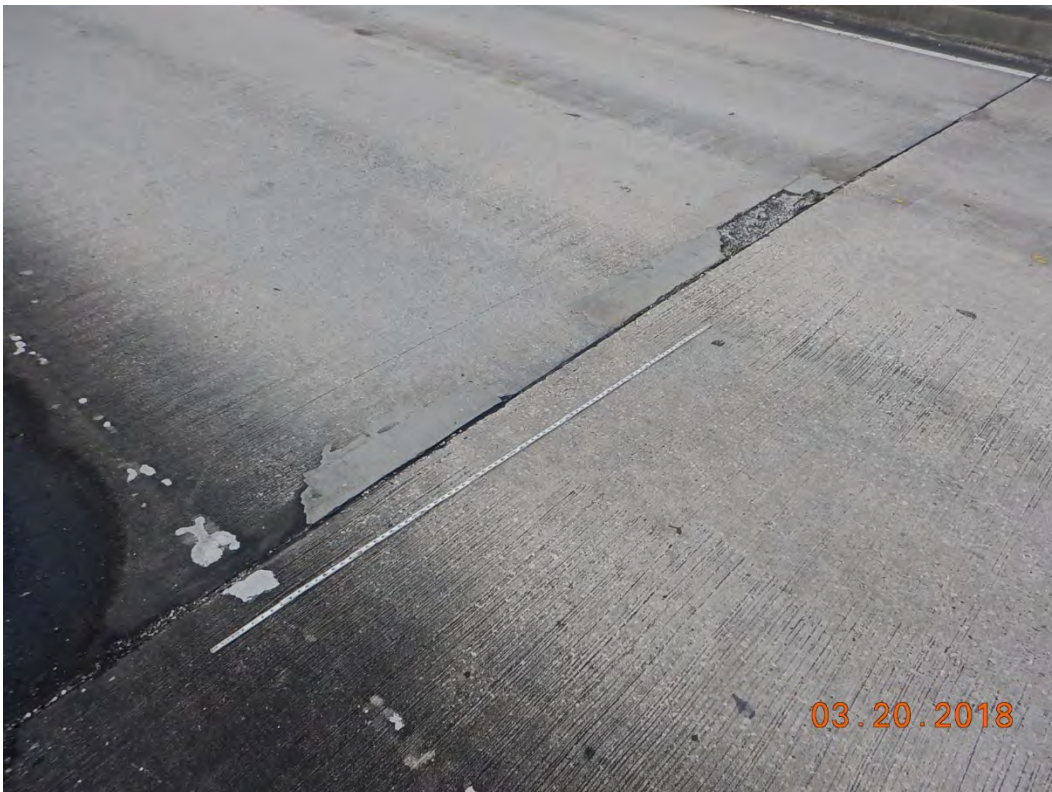
Bent 3 joint has two repairs with shrinkage cracks and a spalled area 40 in. x 8 in. x 2 in. along Span 2 side of the joint. Refer to Photo 4. REPAIR

Photo 4: Element 301: Showing spalled area at Bent 3 joint.

Repair the failed repaired area along Bent 3 joint in Lane 2.

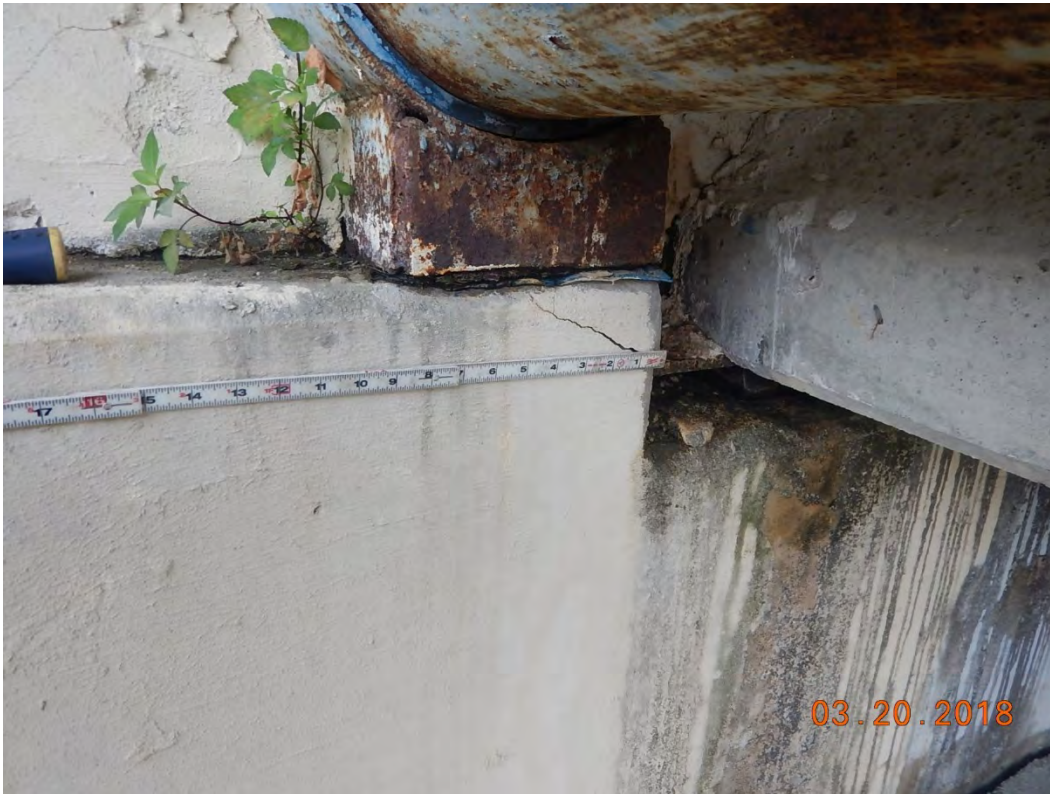
215/3 Previously Noted:  
CS2 = The top edge of Abutment 1 Cap at the east utility has a 10 in. long x 3 in. wide delamination. Refer to Photo 5.

Photo 5: Element 215: Showing delamination at top edge of Abutment 1 Cap.

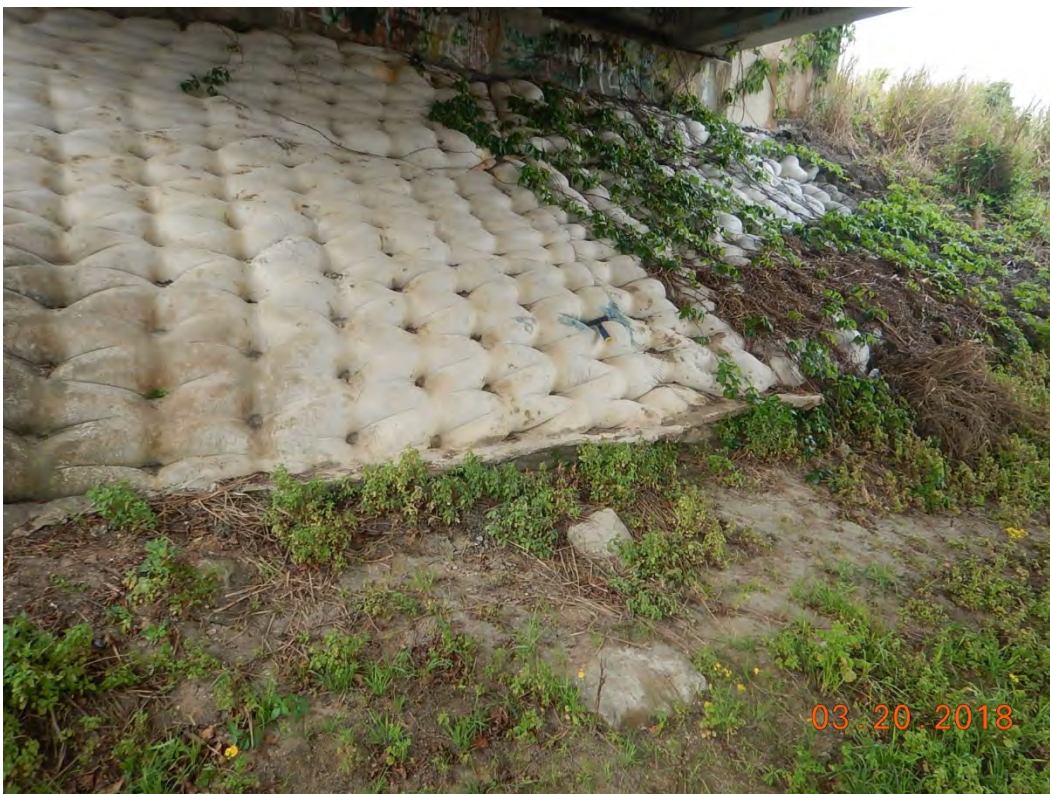
INCIDENTAL:  
There is moderate to heavy vegetation growing on the slope protection at all four corners of the bridge. Refer to Photo 6.

Photo 6: Element 8396: Showing vegetation growth at north slope protection.

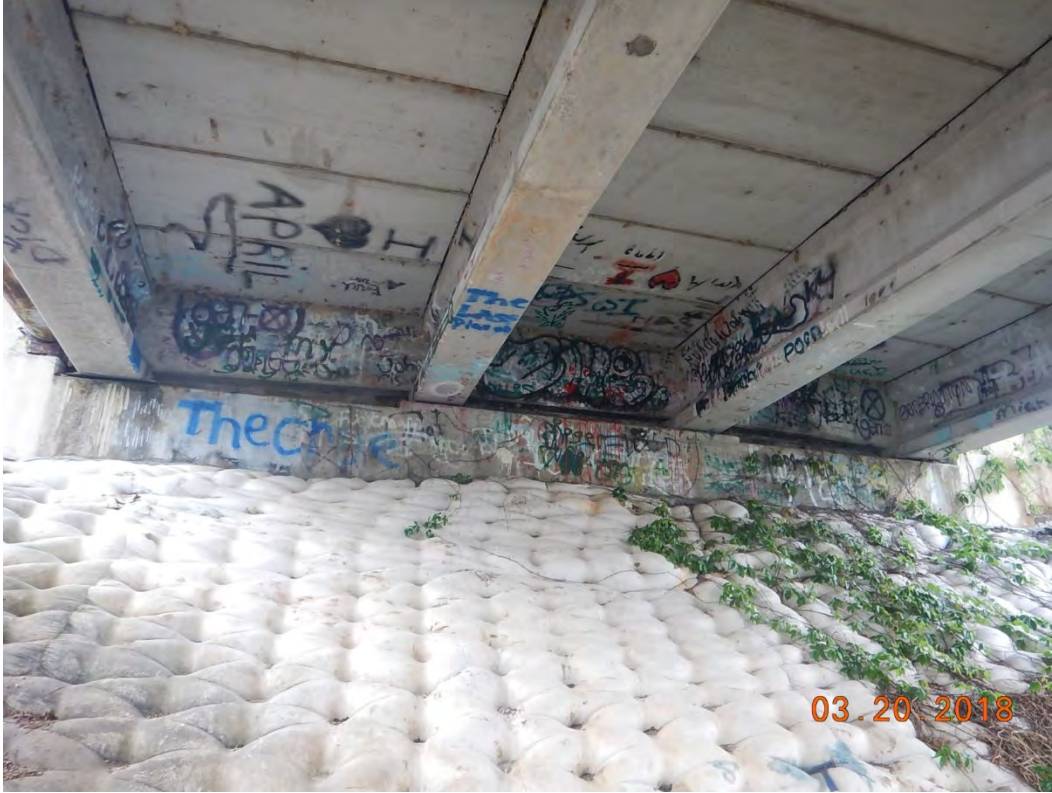
There is graffiti on both abutments, both intermediate bent caps, all piles, the north slope and retaining walls. Refer to Photo 7. REPAIR

Photo 7: Inspection Notes: Showing graffiti on bridge underside.

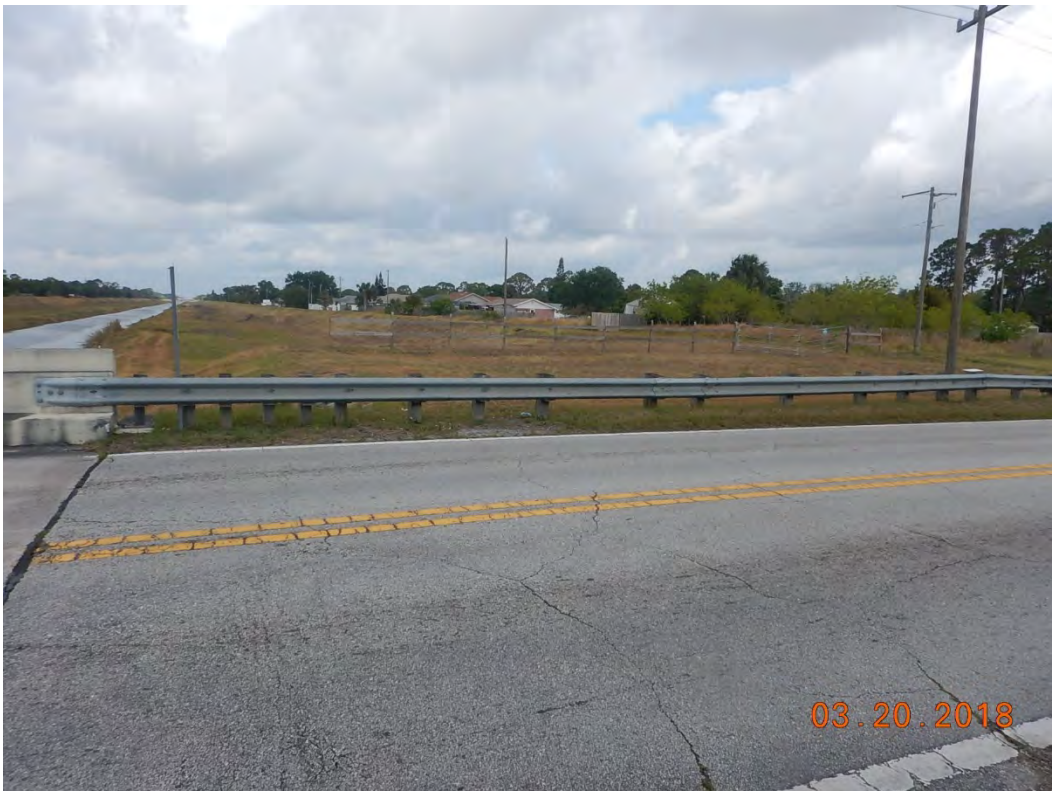
Several guardrail mounted reflectors are either broken or missing throughout the approach guardrails. Refer to Photo 8. REPAIR

Photo 8: Inspection Notes: Showing broken and missing guardrail mounted reflectors.

Replace all broken or missing guardrail reflectors.

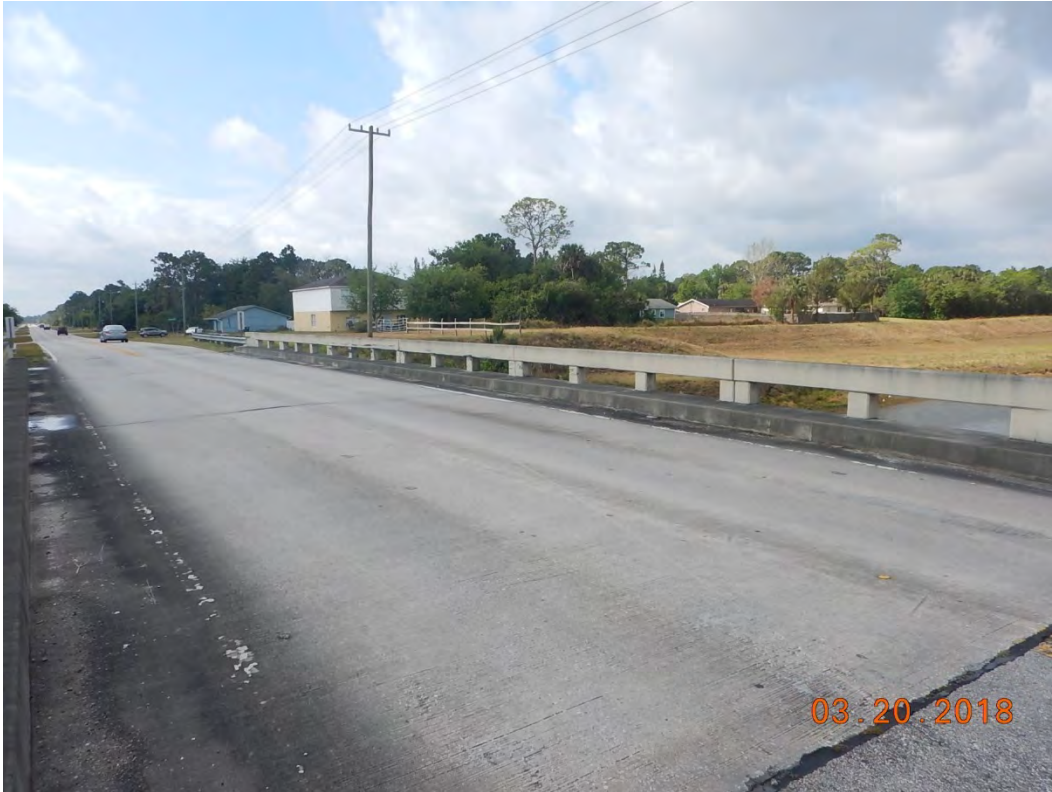
The deck striping is moderate to heavily chipped and worn on the structure but in good condition at both approach roadways. Refer to Photo 9. REPAIR

Photo 9: Inspection Notes: Heavily chipped and worn deck striping.
